NIST Special Publication 901

The January 17, 1995 Hyogoken-Nanbu (Kobe) Earthquake

*Performance of Structures, Lifelines, and Fire
Protection Systems*

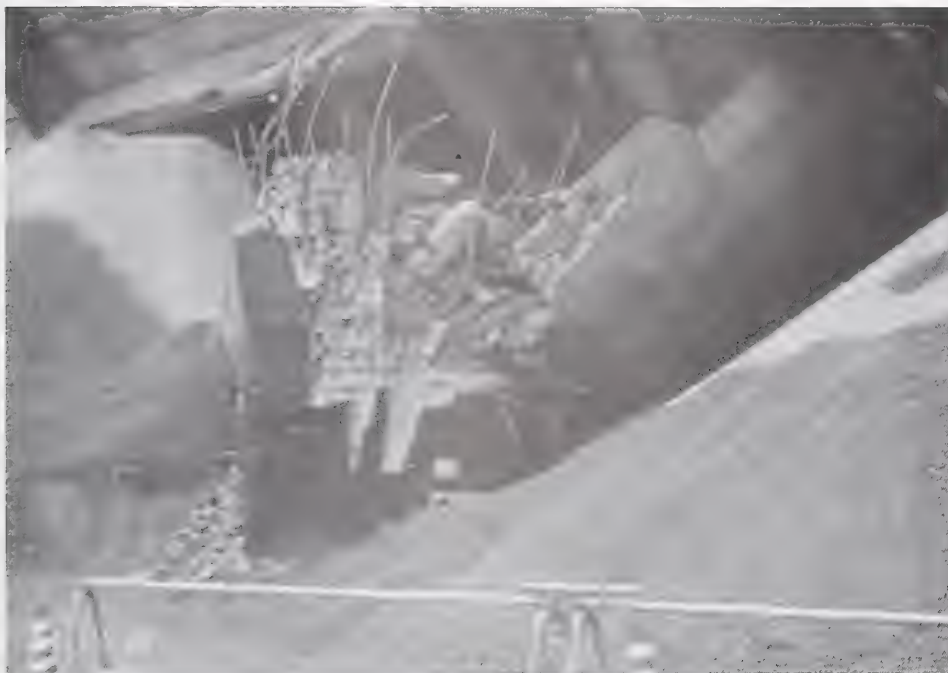
Figure 4.2.17 General view of Hashin Expressway (Route 5) near Uozaki showing collapse of section over Pier 240 in middle distance.

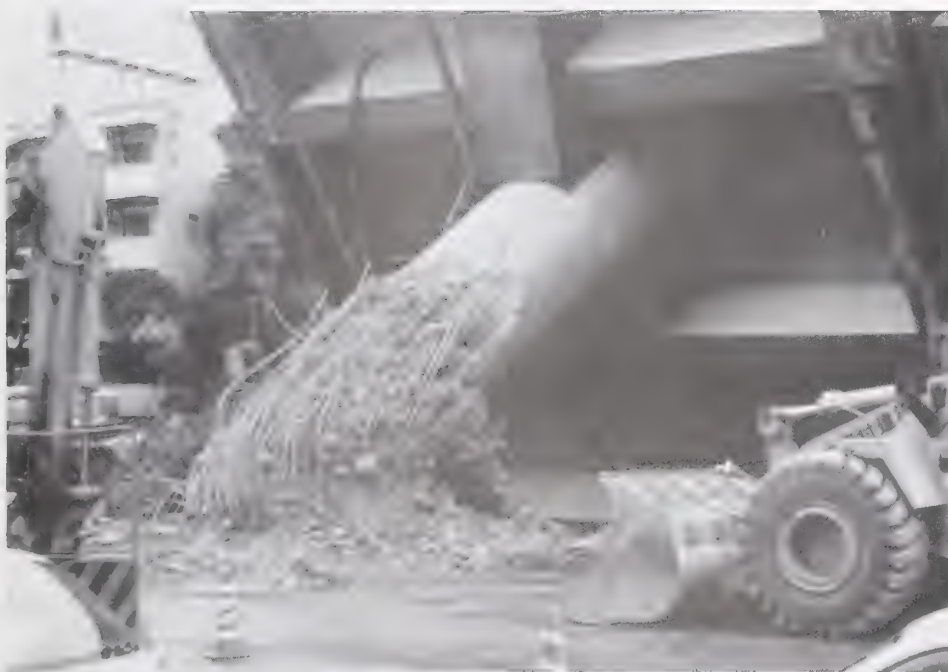
Figure 4.2.18 Pier 240 of Hanshin Expressway showing temporary repair to this single column bent.

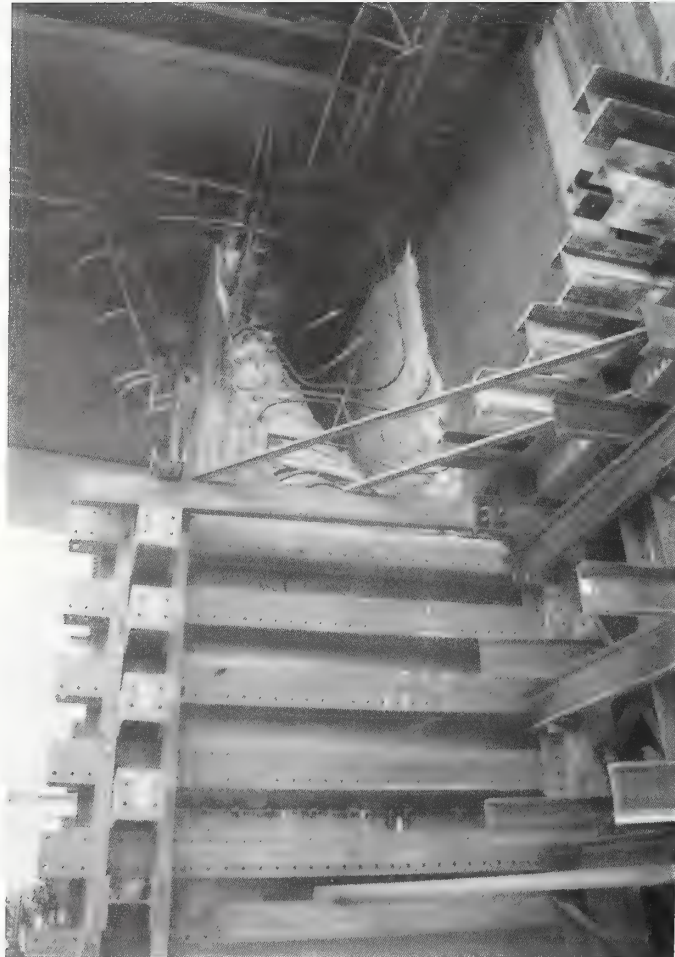
Figure 4.2.19

Shear failure in Pier 240 of Hanshin Expressway showing temporary repair to column to prevent total collapse.

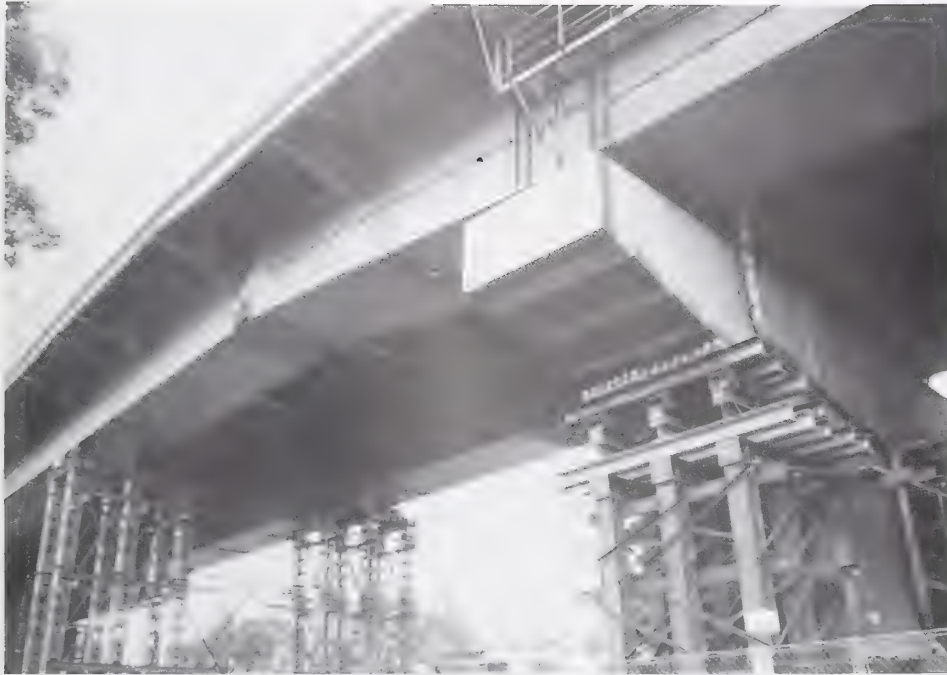
Figure 4.2.20 Compressive failure in lower flange of steel box girder between Piers 238 and 239 of Hanshin Expressway.

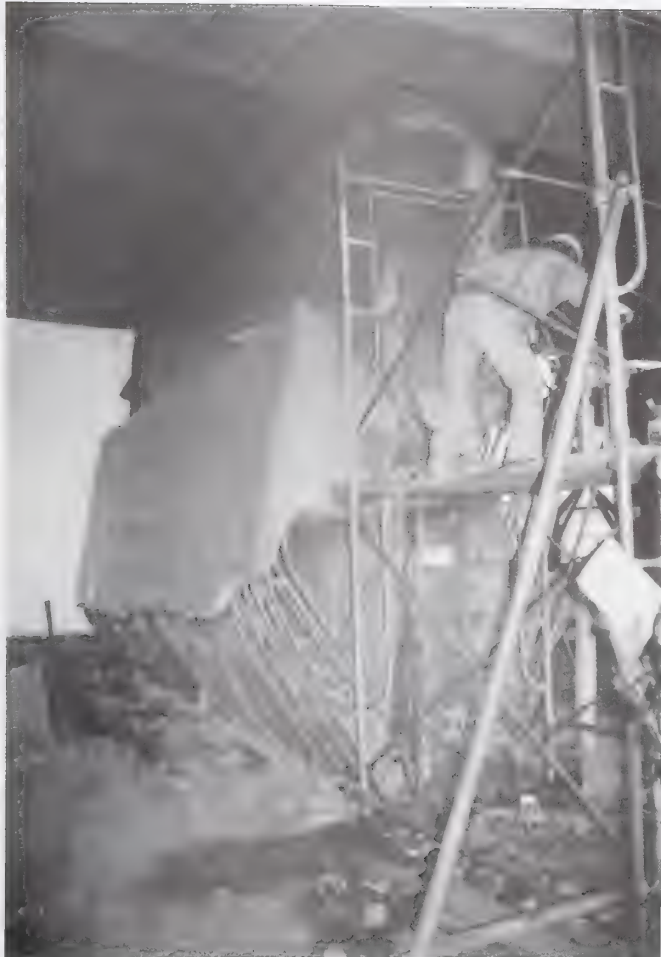
Figure 4.2.23 Shear failure in wall pier (west face), Moribe Viaduct.

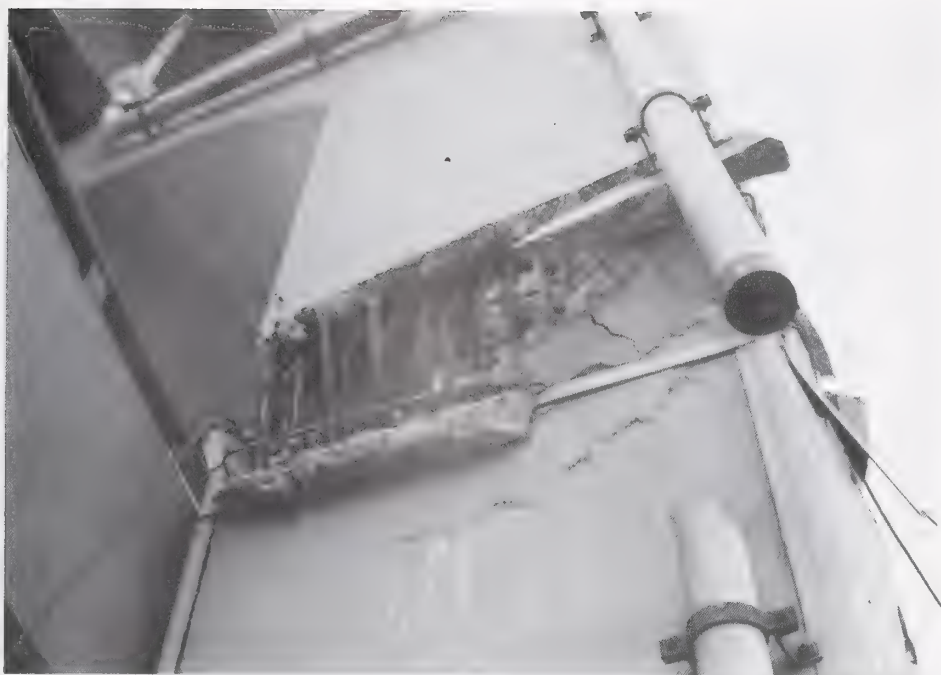
Figure 4.2.26 Hinge formation in east column of Pier 23, Kobe-Ohashi.

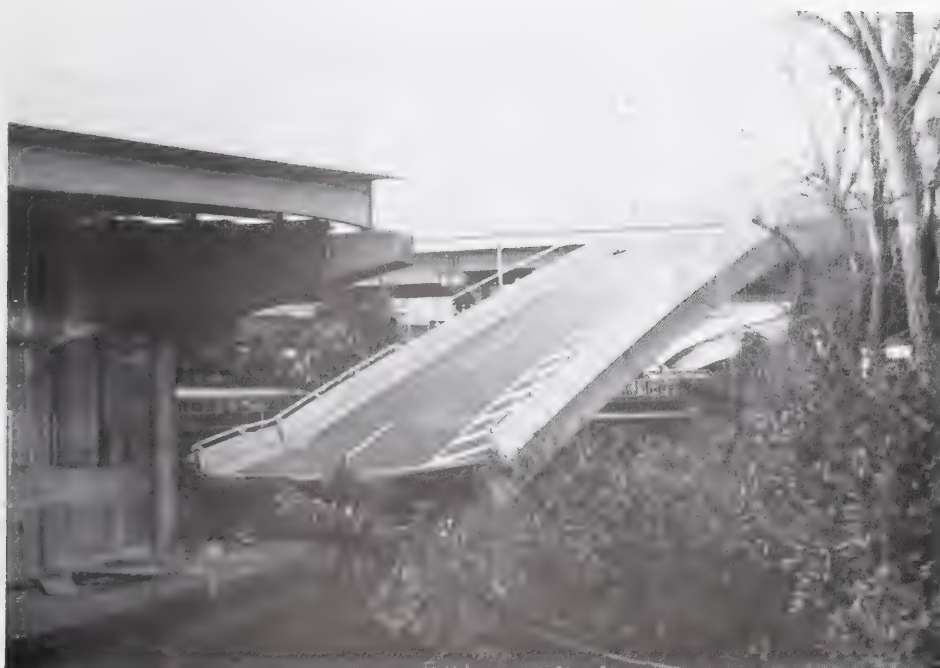
Figure 4.2.27 Collapse of Southeast Ramp at the Minatogawa Interchange.

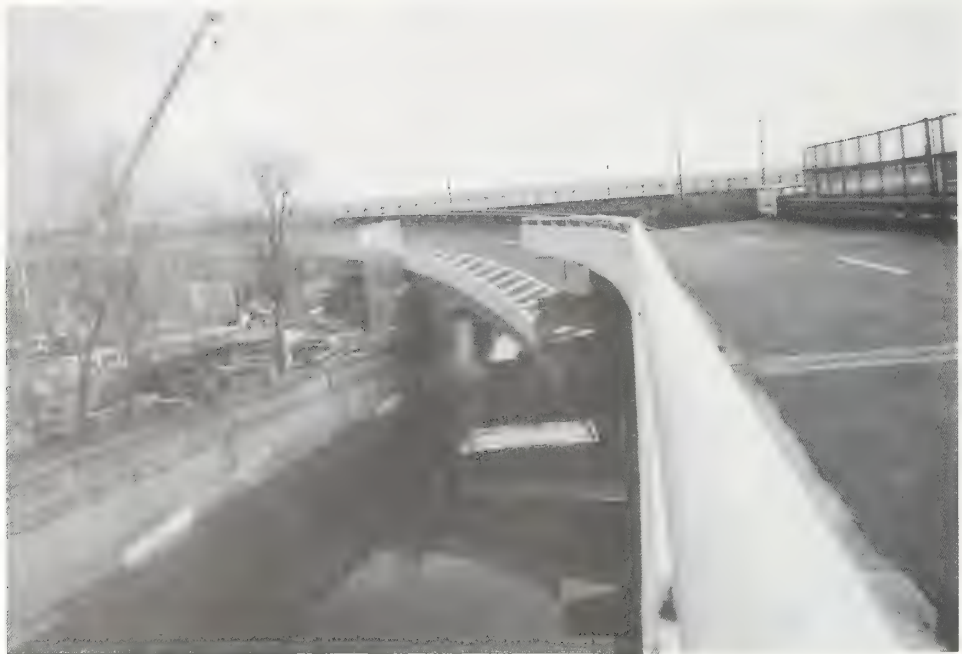
Figure 4.2.28 Collapse of Northeast Ramp at the Minatogawa Interchange.

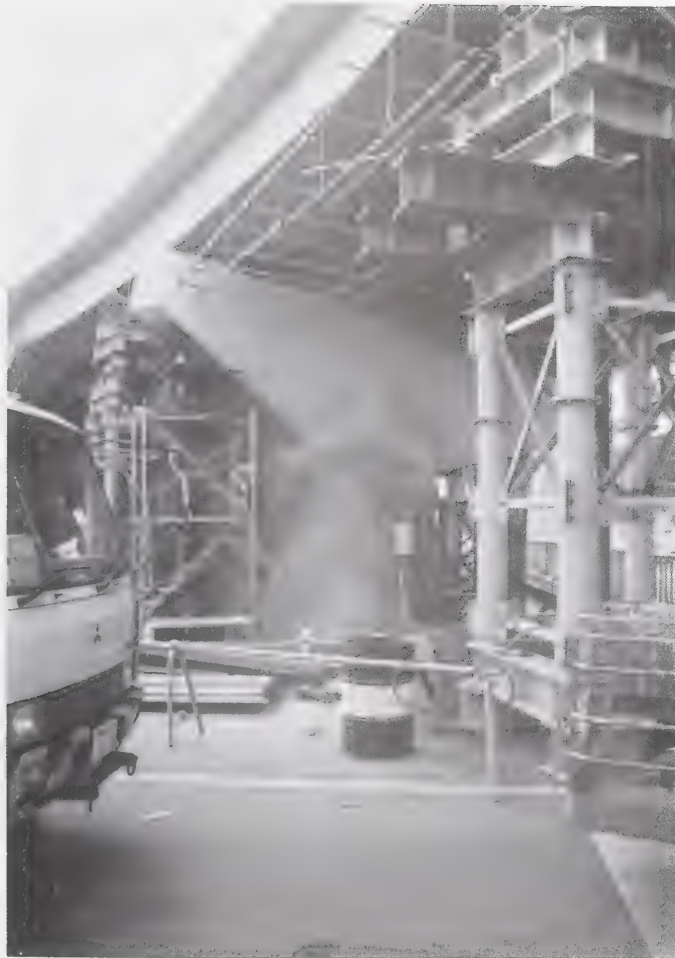
Figure 4.2.30 Column failure in Southwest Ramp at Minatogawa Interchange.

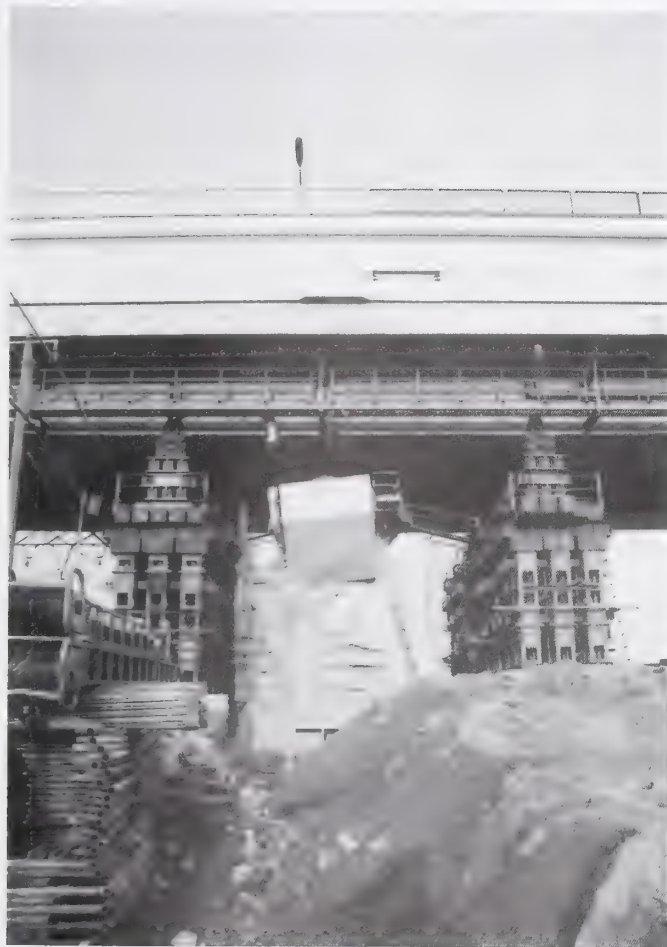
Figure 4.2.32 Side view of shear failure in Pier 688 of Route 3 near JR Sanyo Line.

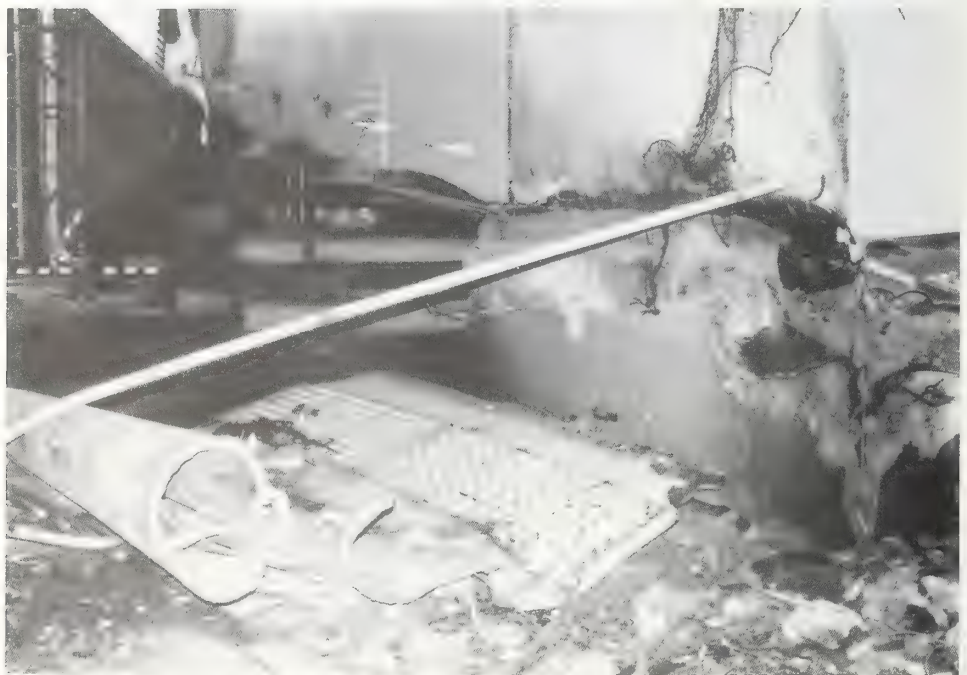
Figure 4.2.34 Pier 55, Route 3 near Tateishi showing buckled steel plate on ground.

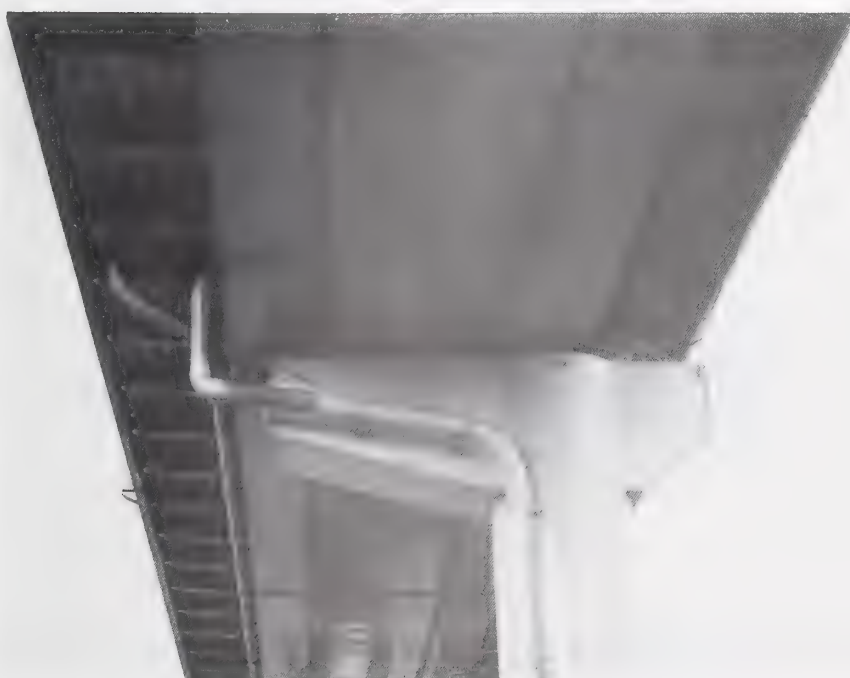
Figure 4.2.38 Failed bearings and lateral offset at top of Pier 586 of westbound Route 3.

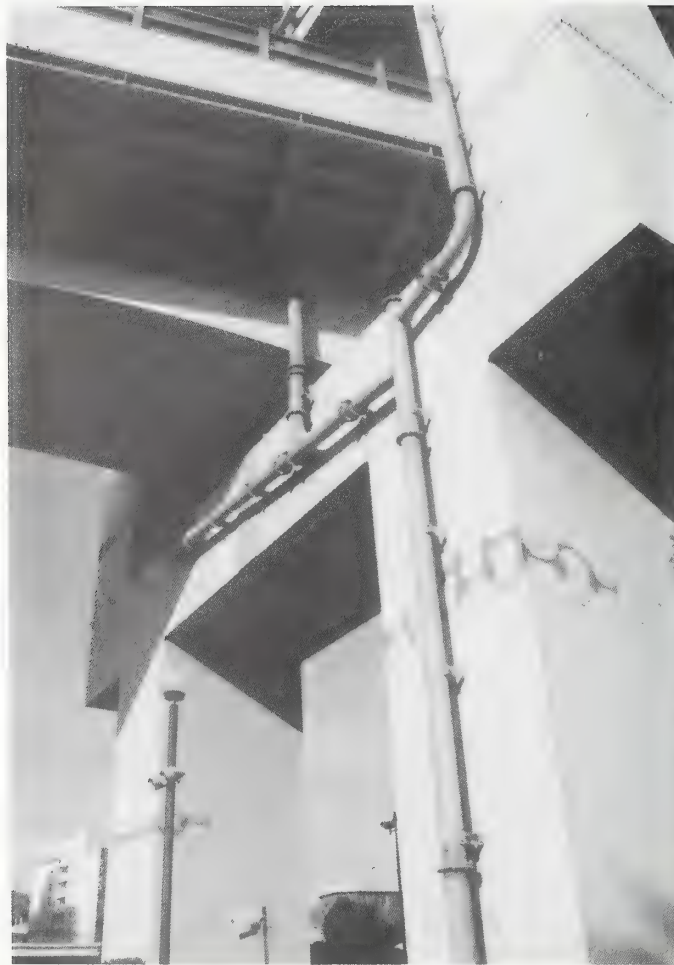
Figure 4.2.39

Local buckling in steel box columns at Pier 41 of the Hamate By-Pass Viaduct.

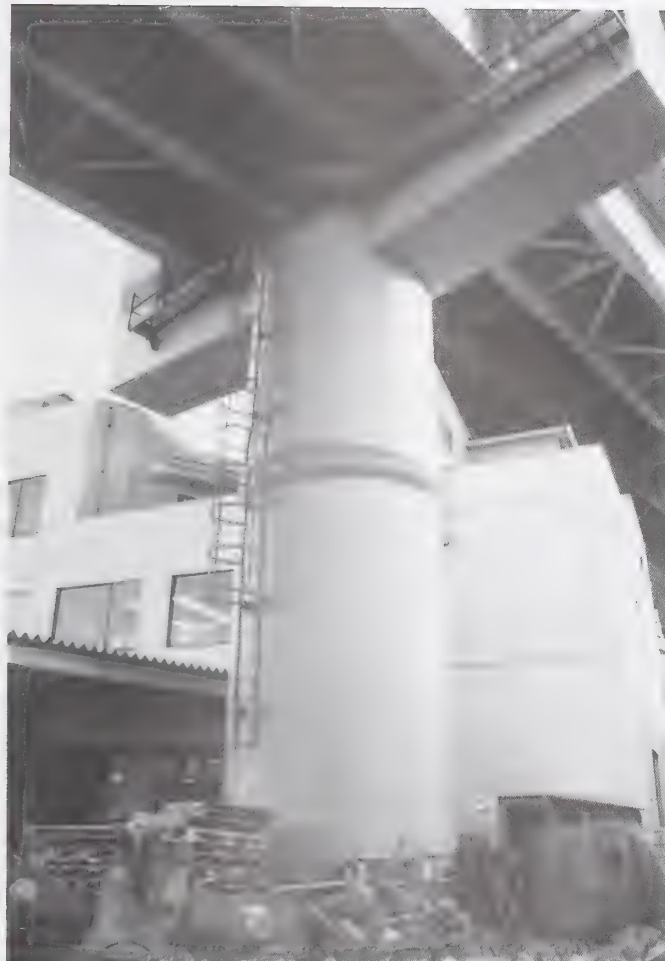
Figure 4.2.40 Buckling in steel columns at Pier 49 of the Hamate By-Pass Viaduct.

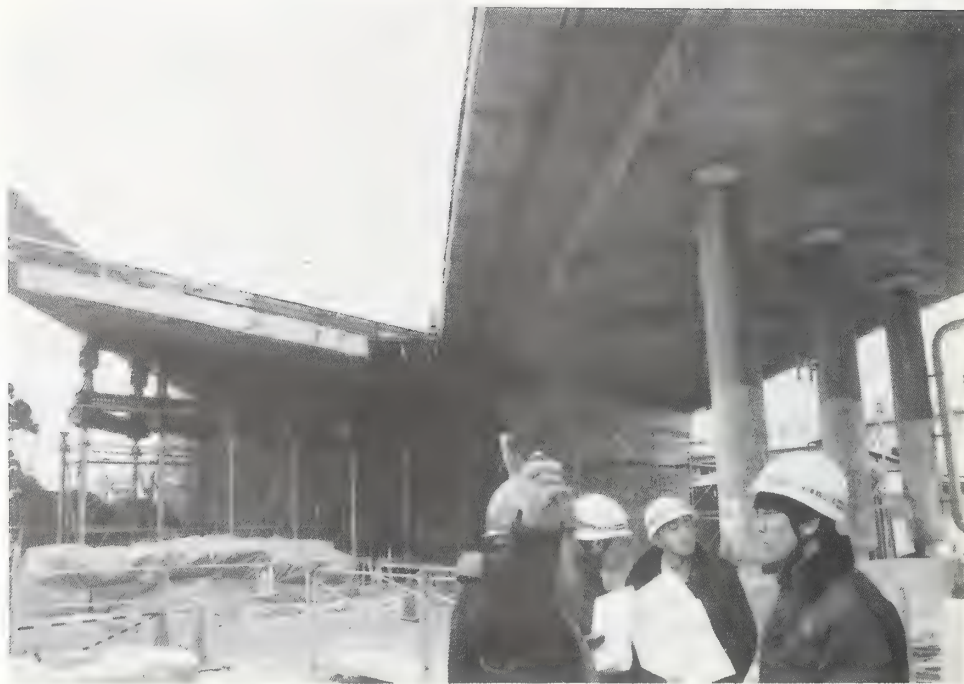
Figure 4.2.44 Approach span at edge of seat at Pier 134 of Shukugawa Bridge due to lateral movement of the pier by about 1 m towards the center of the channel.

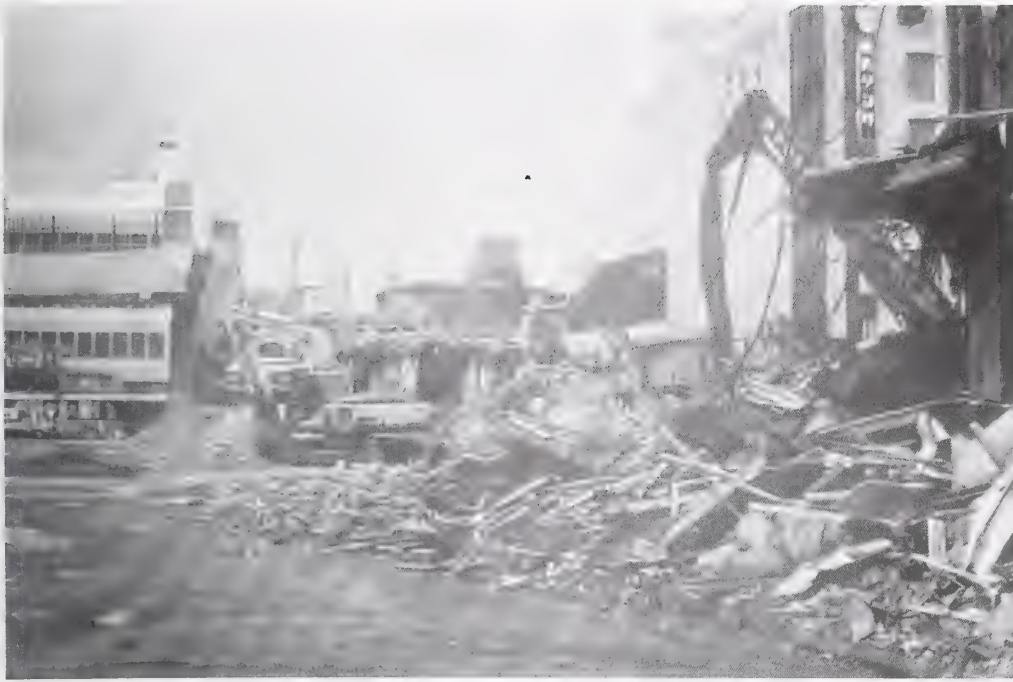
Itami Line The Shin-Itami station collapsed (Figure 4.3.11). The elevated station was at the end of the Itami Line. Railroad tracks gradually rose through a segment of elevated embankment and a series of elevated structures and ended at this station. The collapse may have been caused by a whipping action.

Figure 4.3.11 Collapsed Shin - Itami Station.

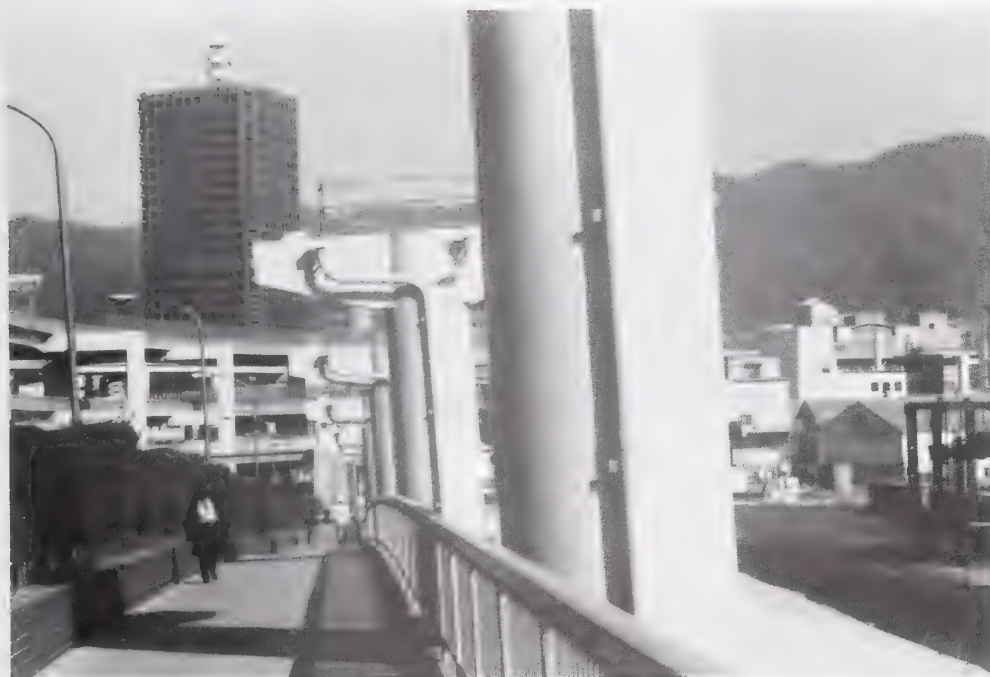
the east side of the steel box girder tore off the web of the girder. Pier 35 tilted to the north (Figure 4.3.12) and the southern span dropped off and the superstructure yielded near the bent cap. Piers 56 to 59 tilted to the west (Figure 4.3.13) which may have been caused by liquefaction in this area. The first span at the south end of the Kobe bridge offset approximately 15 cm to 20 cm. Although the whole Port Island settled approximately 0.5 m to 1 m, no columns supporting the train had suffered any damage in this area.

Figure 4.3.12 Tilted pier - Port Liner.

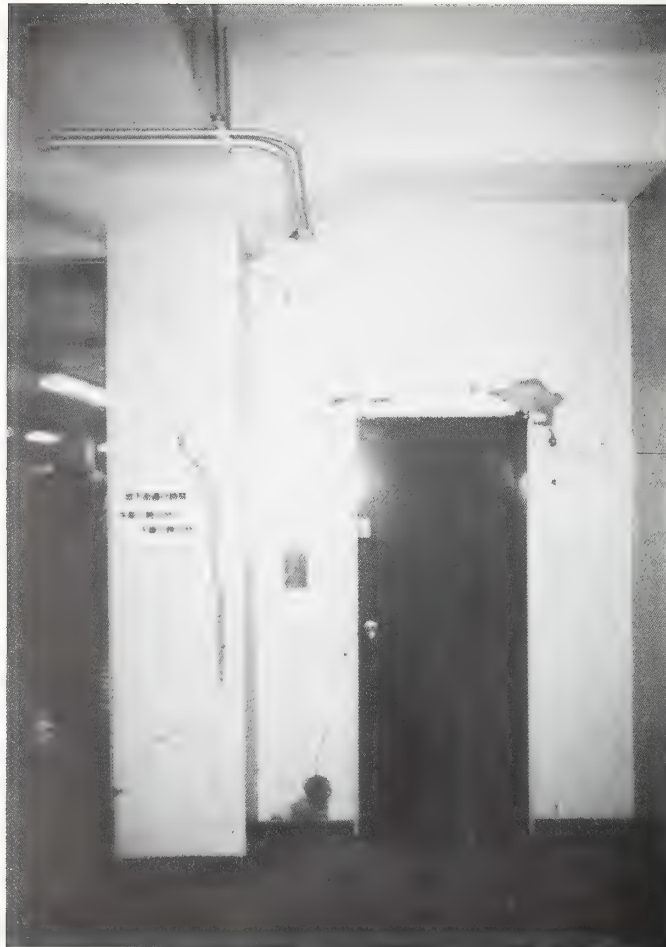
Figure 4.3.15 Cracked reinforced concrete column and concrete panel wall at underground shopping mall near Shin Kaichi Station.

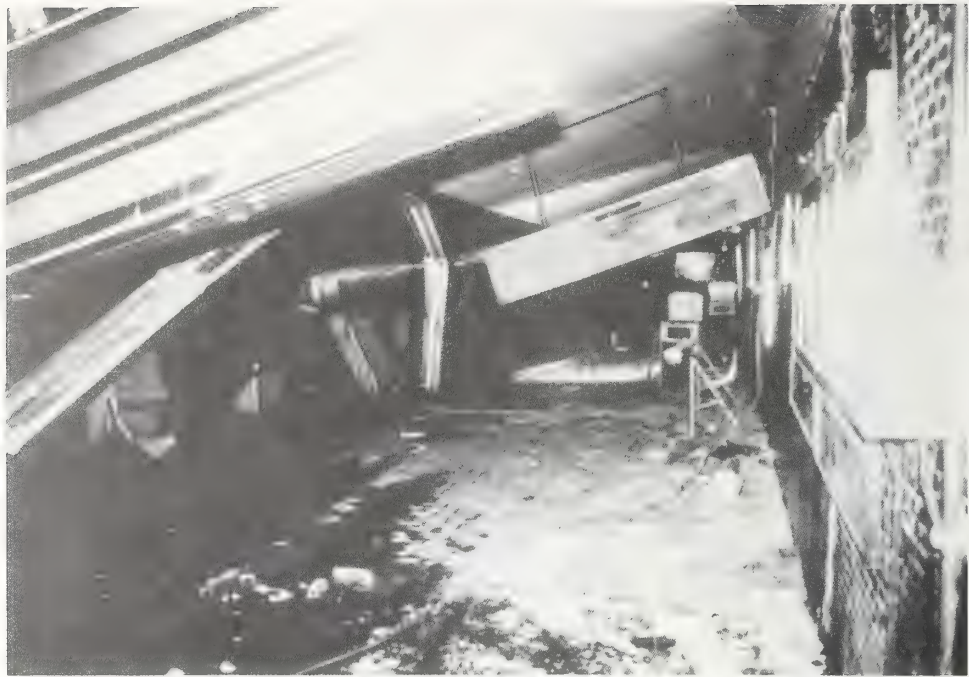
Figure 4.3.19 Roof collapse viewed from the station platform at Daikai Station.

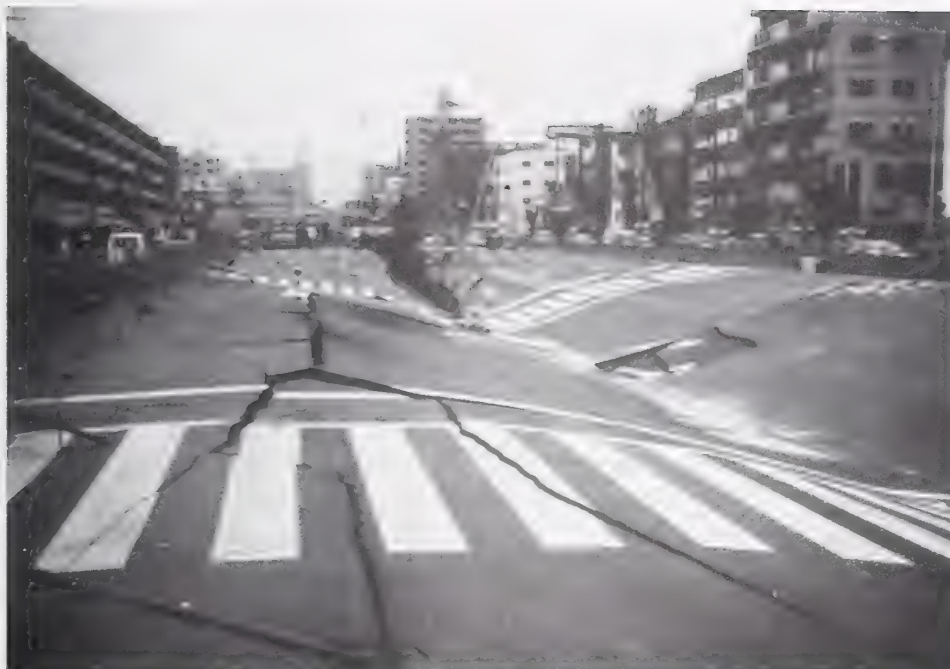
Figure 4.3.21 Subsidence of street surface over the collapsed Daikai Station.

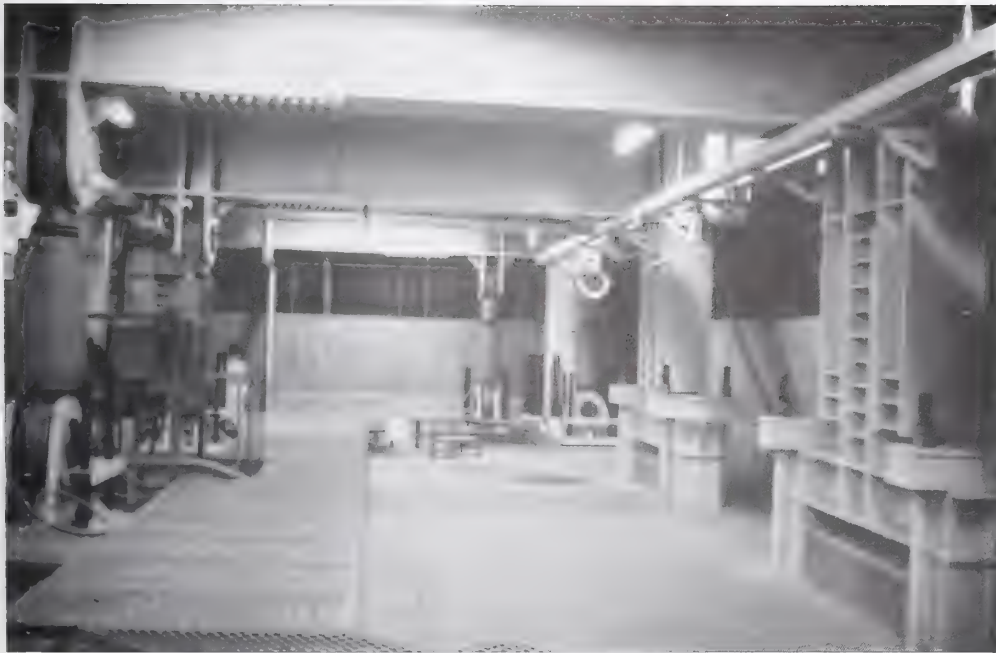
columns is not known, but there are two shear keys on each side of the tower (Figure 4.4.9). These shear keys are detailed to carry lateral load parallel to the foundation wall, including torsion of the building, but no vertical axial load (Figure 4.4.10). The lower end of each ram is supported by the foundation pad and the upper end is connected to a stiff diaphragm, consisting of the deep beams shown in Figure 4.4.11. The shear keys are configured so that they stay engaged when the rams are used to relevel the structure. It is not known if the leveling mechanism is used to compensate for differential settlement of the tower to prevent leaning, or if it is also used to maintain the level between the structure and the surrounding ground. This may be needed to prevent damage to utility lines that enter the building.

Figure 4.4.9 Basement of the tower showing system for leveling the building and shear keys.

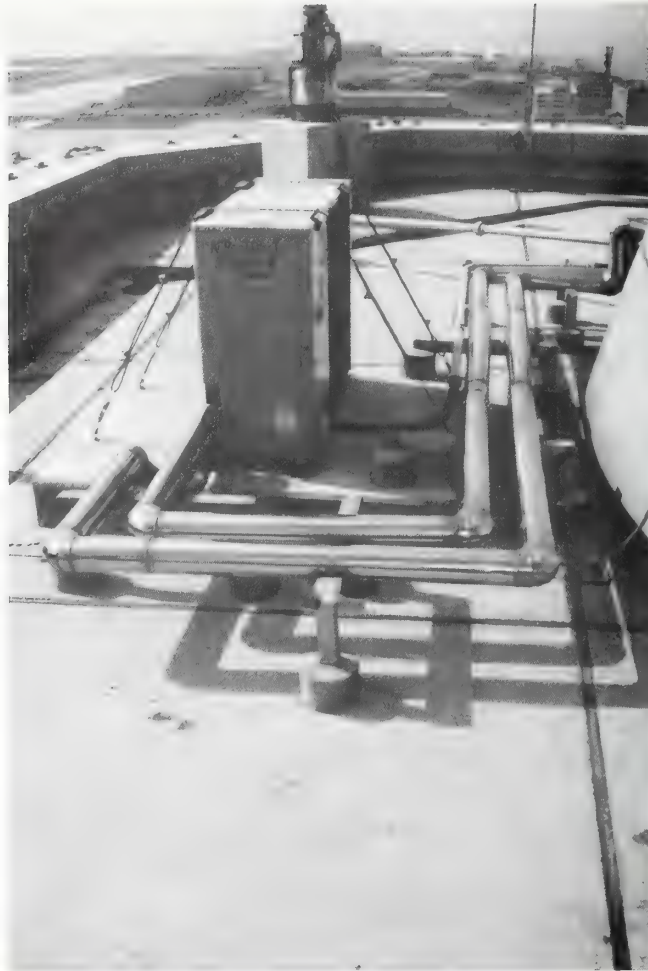
A heat exchanger on the roof was well anchored, as was most equipment observed (Figure 4.4.18).

Figure 4.4.18 Roof-mounted heat exchanger braced with cables.

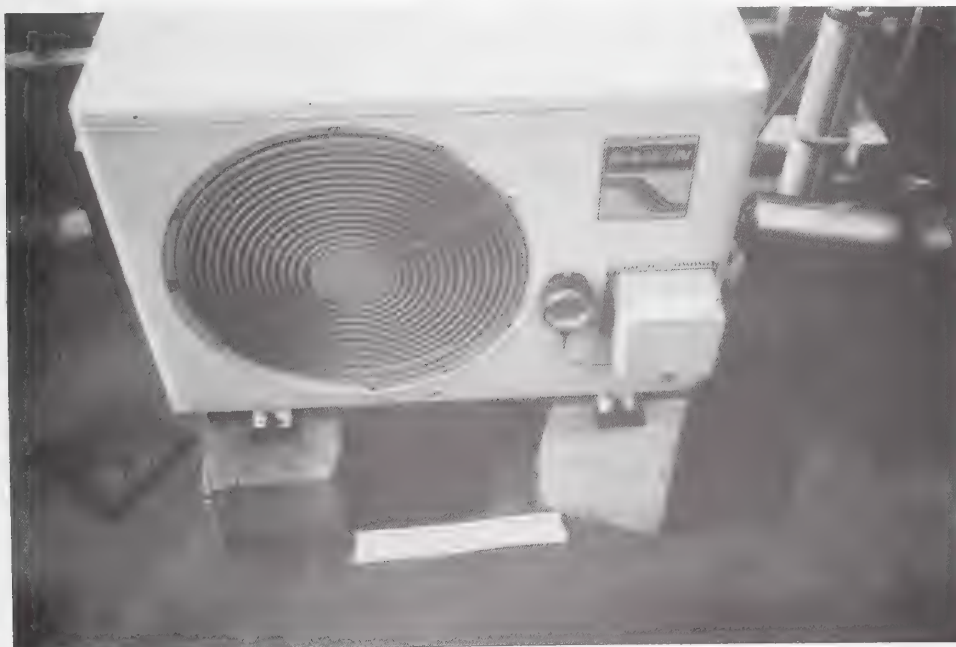
Figure 4.4.23 Heat exchanger on roof near control tower cab is rare example of poorly anchored equipment.

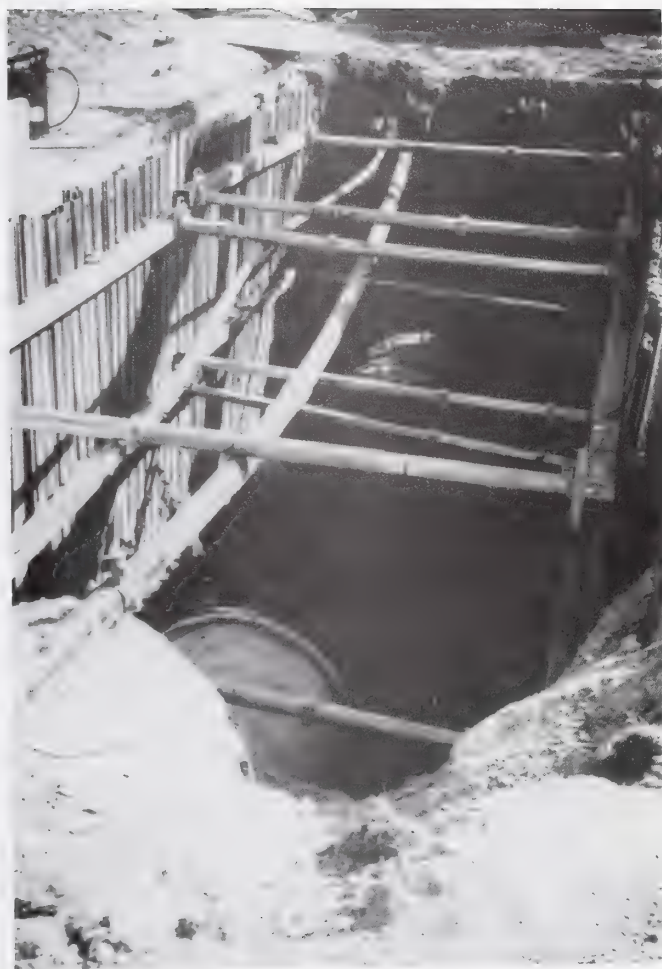
Photo 10 Repair of one of the three 1.2 m treated water lines leaving the Uegahara/Hanshin Plants site.

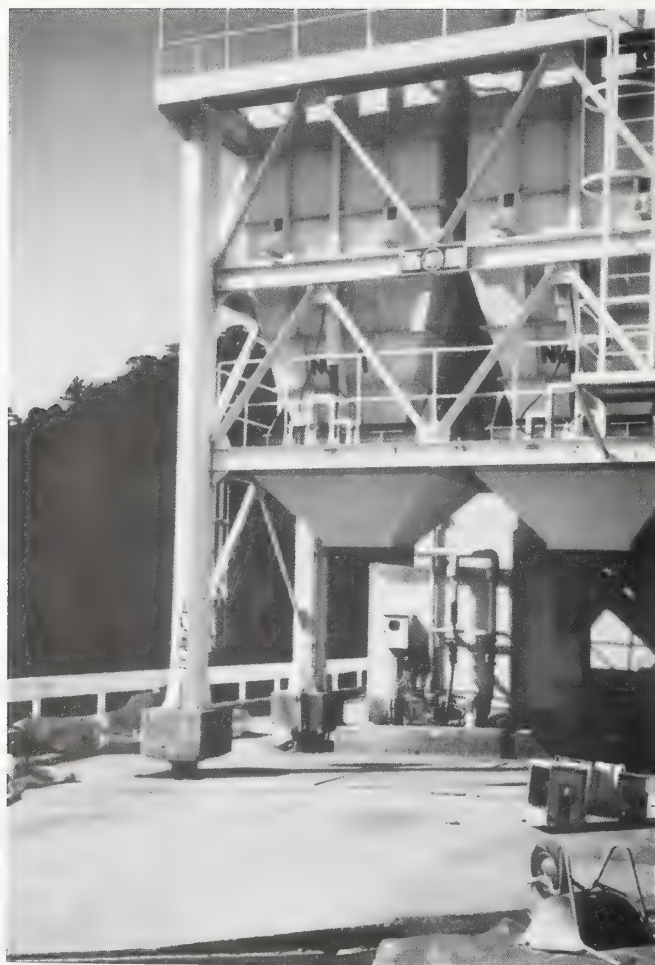
Photo 11 Subsidence (approximately 30 cm) around pile-supported sludge hoppers at Uegahara Plant.

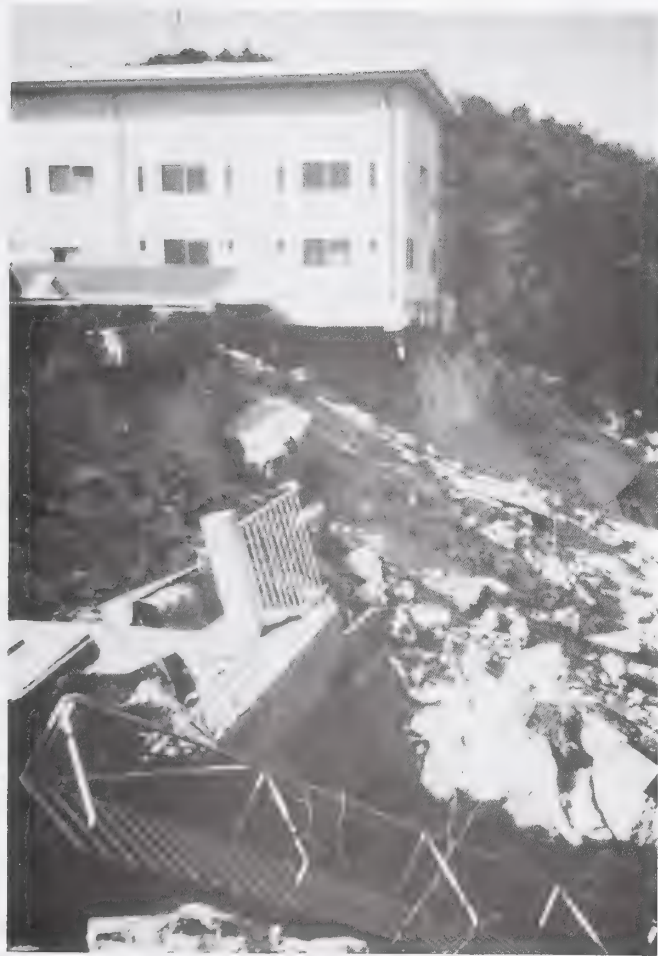
Photo 12 Landslide undermined solids handling building at the Hanshin (Kabutoyama) Plant.

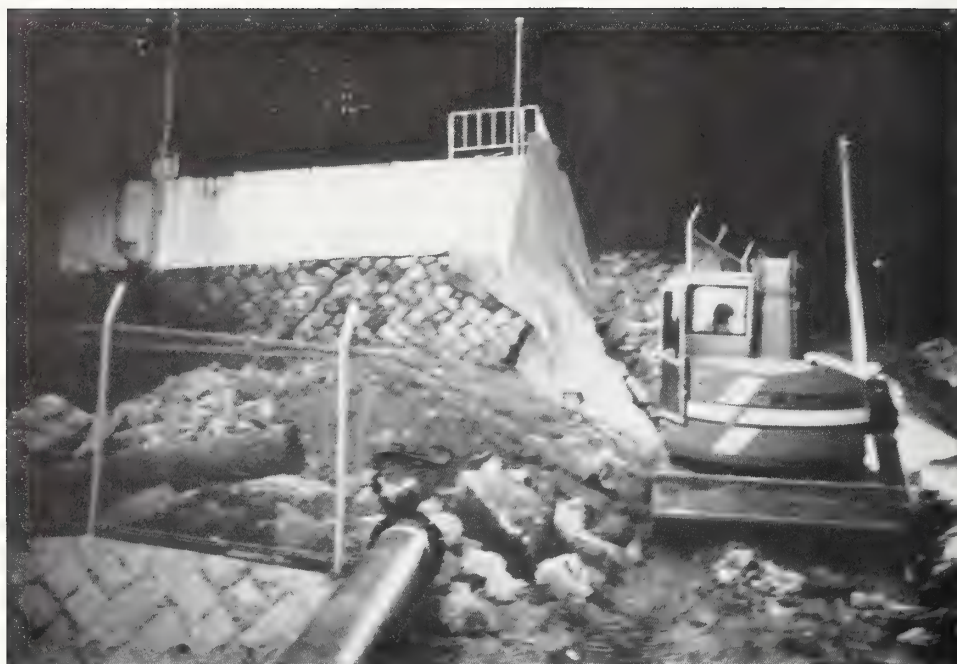
Photo 13 Broken lines to/from backwash tank at the Motoyama Water Purification Plant.

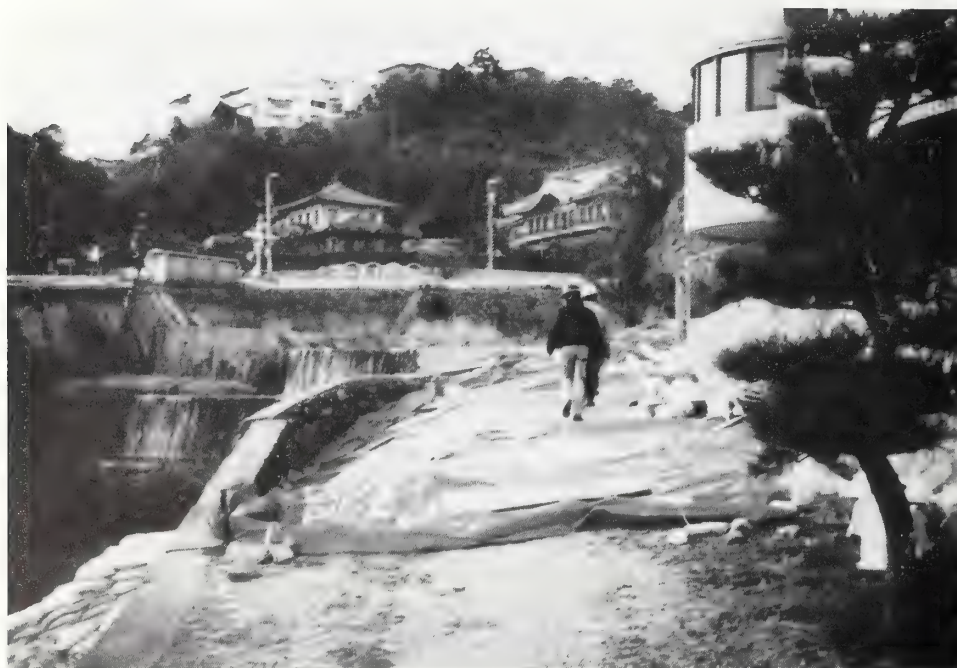
Photo 14 The retaining wall on the left cracked damaging the overflow line from the Motoyama Plant's intake box.

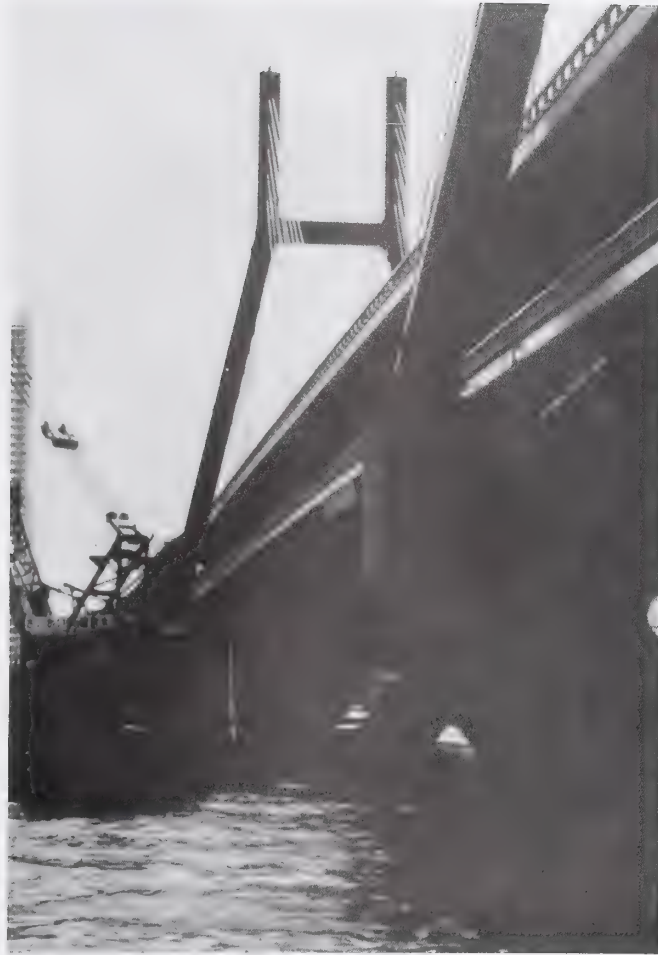
Photo 15 Pipe hanging from bridge to Rokko Island (just to the right of crane cab).

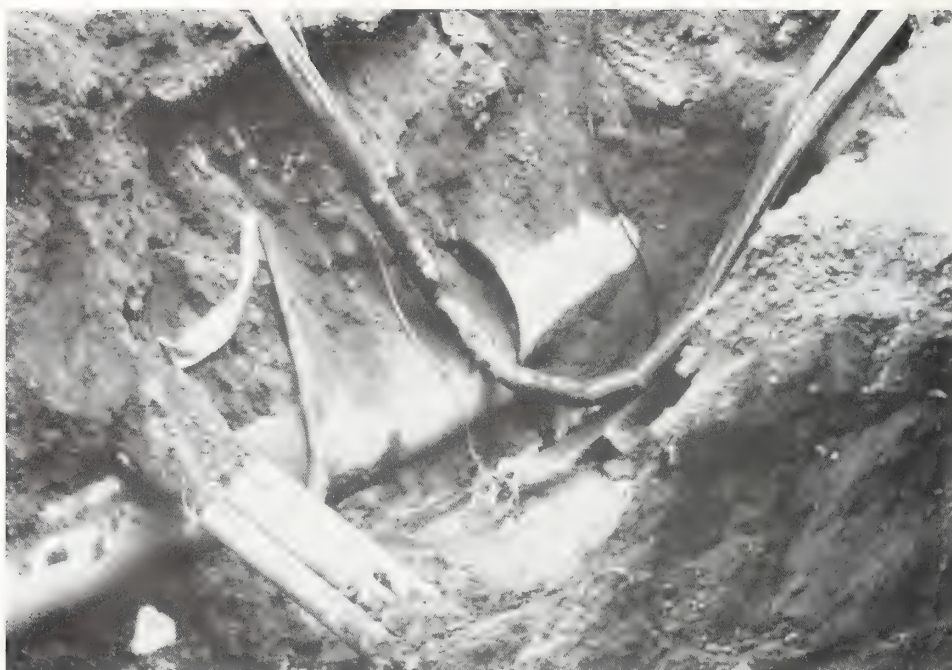
Photo 16 Repair of 700-mm welded steel pipeline which ruptured at a weld on the north side of Port Island in an area affected by liquefaction induced lateral spread. This line carries the entire potable water supply for the island.

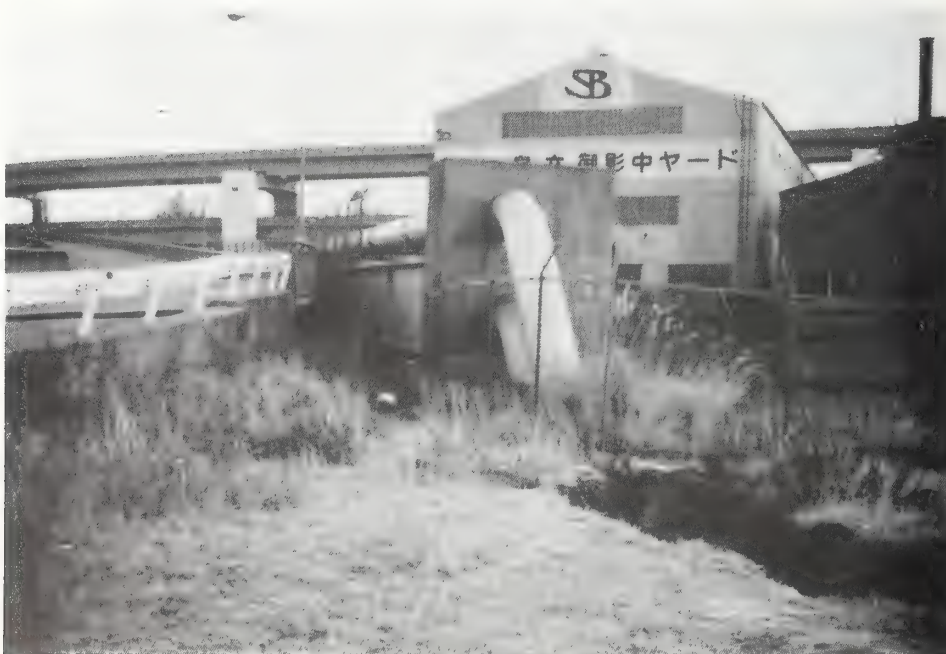
Photo 17 Ground cracking from lateral spread in fill area along a water way. Immediately behind the crack, a pipeline emerges out of the ground to be supported on the bridge.

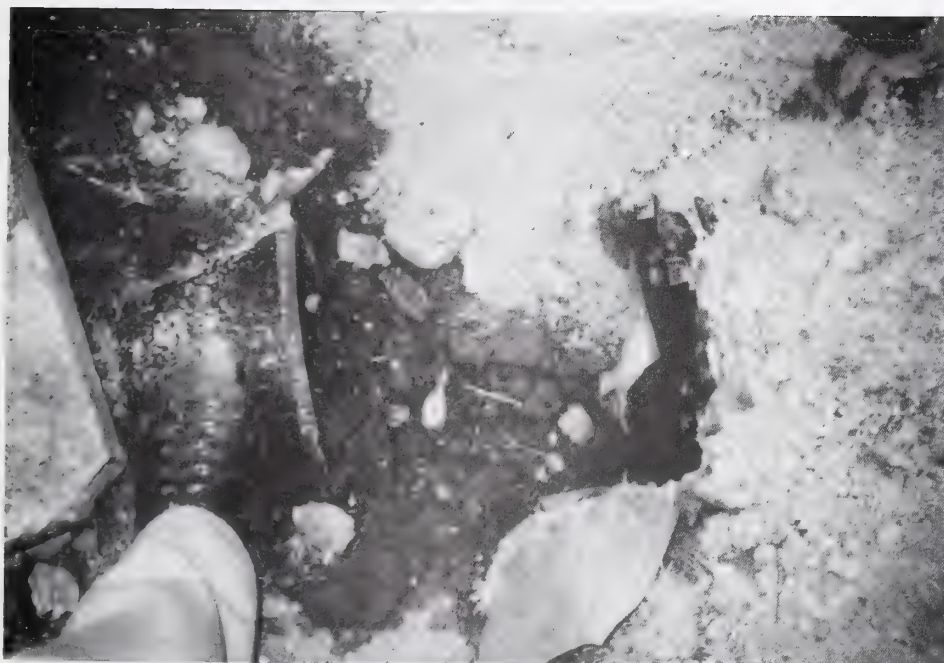
Photo 18 Shows a 300 mm diameter pipe joint in the bottom of the crack (Photo 17), where the bell (to the right) was separated from the spigot (under foot).

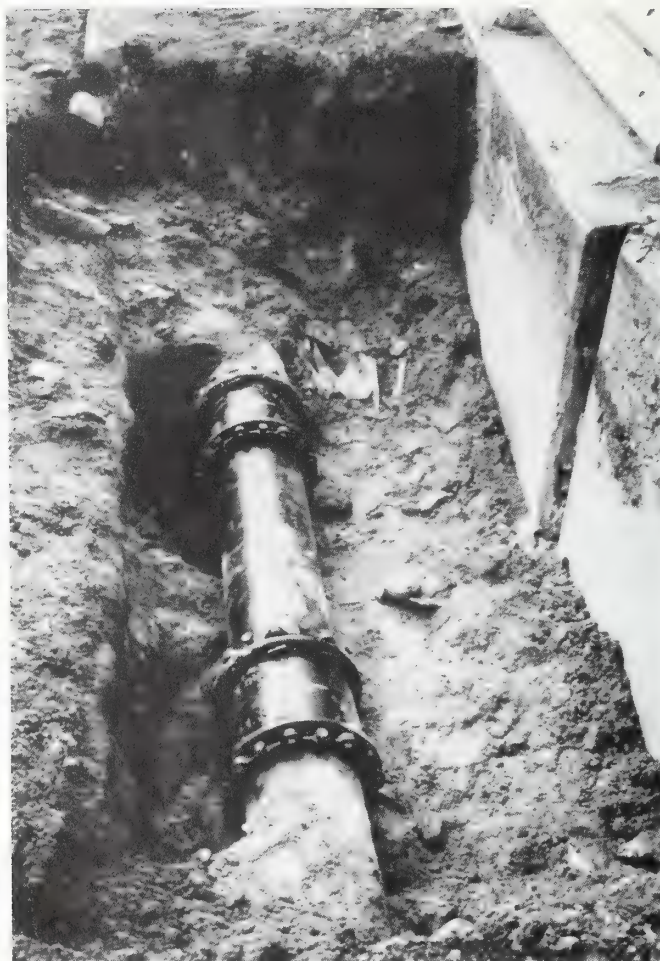
Photo 19 Pipe repair on approach to bridge to island where the wastewater plant was located. Settlement and slight lateral movement (see concrete wall on right) likely caused the pipe failure.

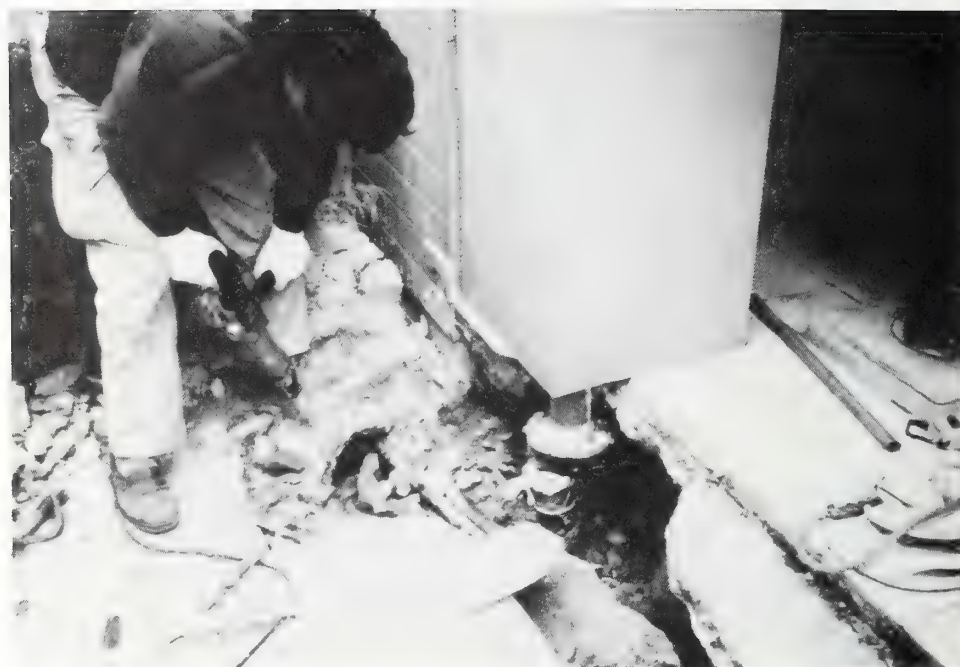
Photo 22 Repair of utility connections in mid-Rokko Island.
